**THE USE OF
CERAMIC COATINGS IN
ORTHOPAEDIC IMPLANTS**

**Titanium Nitride Ceramic
Coating Articulating against
Polyethylene and Cartilage**

implantcoast

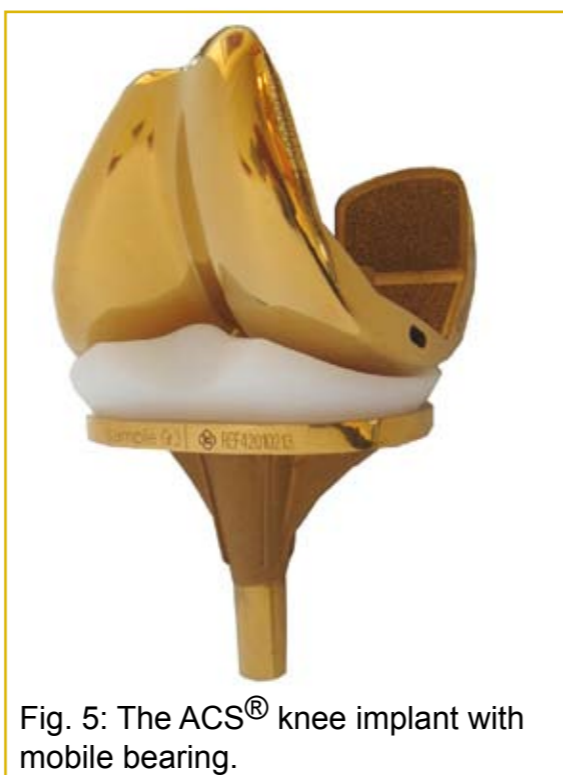
Fig. 5: The ACS® knee implant with mobile bearing.

The ACS knee has its highest surface contact area at extension (where the highest load occurs) and at 60° of flexion.

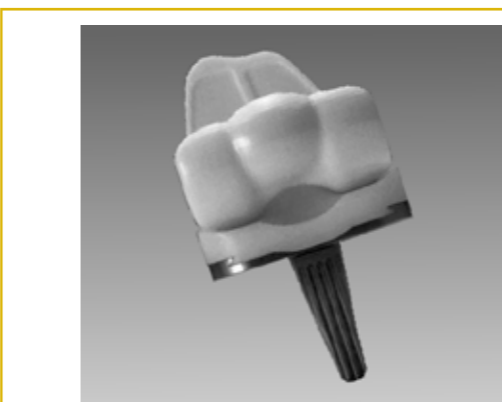
Fig. 8: Block ceramic femur component

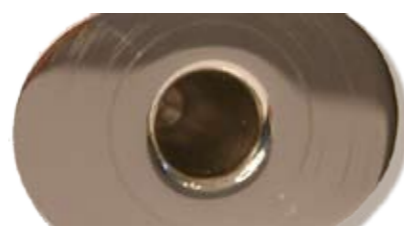
Fig. 11: Scratched non-coated CoCr tibial component

Wear simulator tests are usually done with *new* implants. However it is known that particles in the body such as bone chips and bone cement particles can lead to third body wear.(26)
Ceramic coated implants have a higher resistance to this scratching.(28,29).

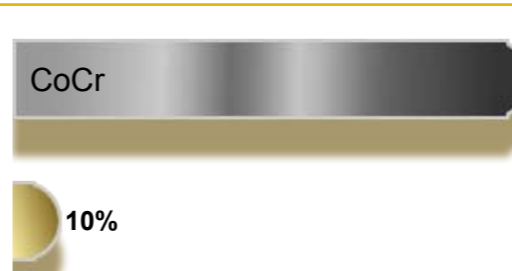
Fig. 20: Chromium ion release

All implants corrode at a rate determined by their surface area and this causes the release of metal ions, Fig. 20 which was derived from a test done at the University of Würzburg, Germany shows that the passive Chromium ion release (without articulation) is less than 10% of a non-coated implant after 10 days in NaCl saline solution at 100°C.(35).

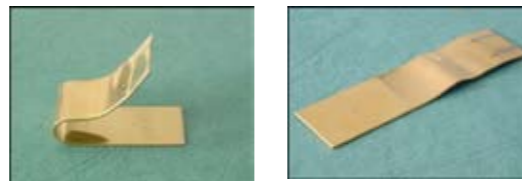
Fig. 24: Bending test to prove adhesive strengths

A metal strip is included with each batch of implants to be coated. To check the adhesive strength of the coating the strip is bent up to 180°. A uniform crack network is seen without delamination proving optimal adherence. (34).

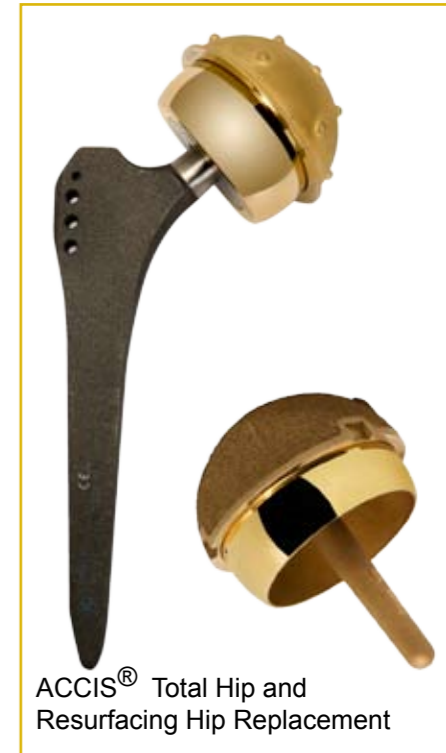
ACCIS® Total Hip and Resurfacing Hip Replacement

A special application of ceramic coating on orthopaedic implants is the ACCIS® coating in which a Ceramic Coated surface articulates against a Ceramic Coated Surface. It is available for Total Hip and Resurfacing Hip arthroplasty. A dedicated brochure is available.
